Workplace Health and Safety Queensland - Pile Driving Incident – Tully – Preliminary Brief
25/9/2008

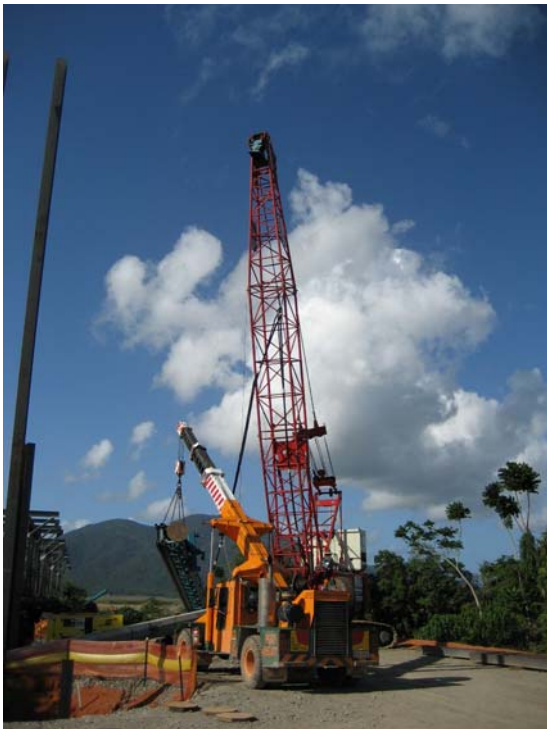
On 19 September 2008 a serious incident occurred near Tully in North Queensland when a 30 metre tower of a pile driving rig became detached from a lattice boom crawler crane and fell with a 12 metre long concrete pile. One worker, located on the ground in front of the crane, was fatally injured. The crane operator was critically injured when one end of the pile became embedded in the crane cabin as a result of the fall. It is understood an attempt was being made to lift the pile into position under the hydraulic hammer, with the auxiliary hook on the mobile crane.

Photograph 1- Incident Scene

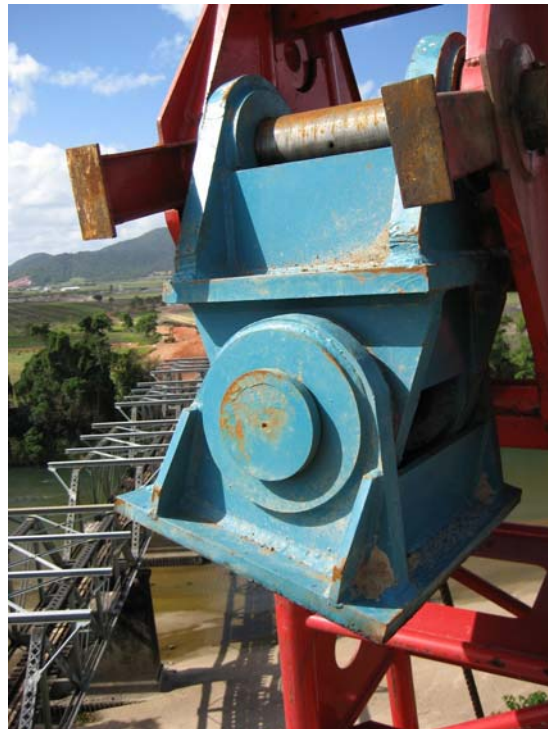
Photograph 2 – Swivel which connects the piling rig tower to the boom head of the crane

The pin has a diameter of approximately 140 mm and passes from the piling rig tower into a large swivel connector mounted on the boom head of the crane. The swivel can be seen in photograph 2, but it should be noted that this connector is rotated downwards in the photograph. The position of the swivel connector is indicated in the elevational view of the rig (Figure 1). The flange on the pin has been fabricated by welding a steel ring on to the end of the pin. Photographs 3 and 4 show views of the pin and flange ring respectively, following the incident. The weld between the pin and flange ring, located at the end of the pin, has failed. Figure 2 shows a sectional view of the pin and the location of the weld between the pin and flange.

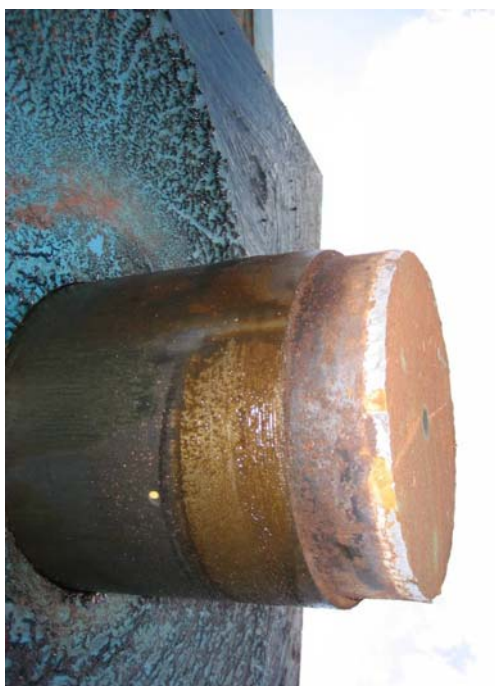
A preliminary examination of the incident scene has been undertaken. The exact sequence of events is still being investigated and the piling rig has been extensively damaged. However, the examination has revealed that the flange on the main structural pin connecting the piling rig to the boom head on the crawler crane has failed. This has permitted the pin to become dislodged and has resulted in the piling rig falling away from the boom tip and striking the ground along with the concrete pile.

Photograph 3 - Main structural pin connecting the piling rig to the boom head on the crawler crane

3. All pins on the swivel connector be removed and inspected to determine if the flange has been welded onto to the pin. If it has been welded the pin is to be replaced by a new pin that has a flange constructed by a method other than welding (i.e. forged or machined). This pin is to be inspected and certified by a suitably qualified professional engineer.

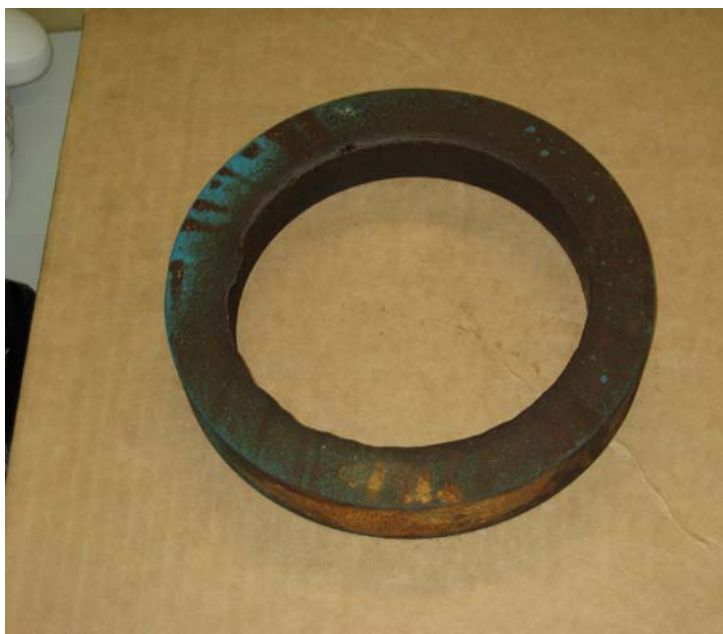
Photograph 4 - Flange on the main structural pin connecting the piling rig to the boom head on the crawler crane

The failed pin and flange ring will be independently examined for material specifications and weld characteristics. However, irrespective of these results WHSQ considers that welding a ring onto the pin to prevent the pin becoming dislodged is **unacceptable** for the following reasons:

- The pin is a critical structural item and failure of the pin flange will cause the piling rig to fall off the crane.
- The piling rig is exposed to severe cyclic loading from the hydraulic piling hammer and fatigue of the weld over time will be likely.
- The pin flange will be exposed to direct loading, acting along the length of the pin, when forward tilt is applied to the piling rig tower.
- Non-destructive examination of the weld will be difficult due to the pin's location in the swivel connector.

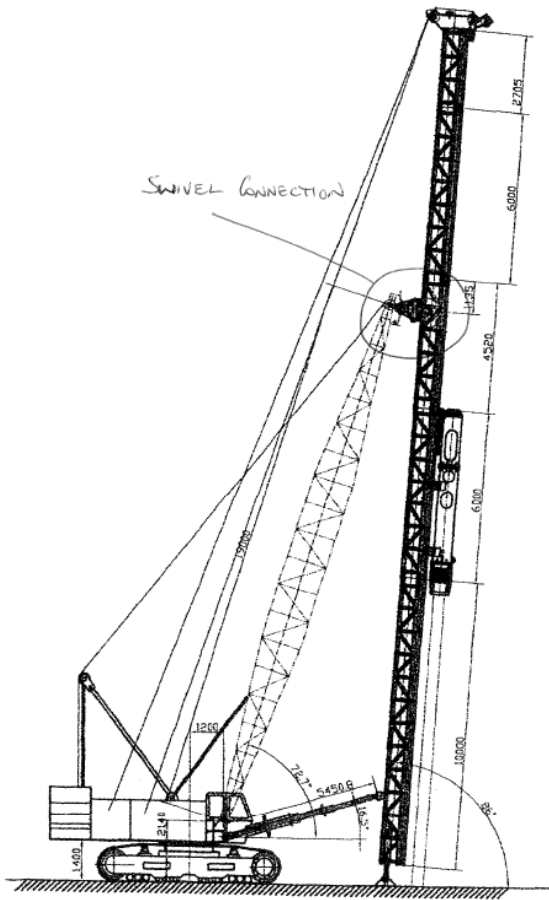
Figure 1 – Elevation view of the rig

The pile driving rig is manufactured by Guandong Liyuan Machinery and is also known by the brand name “Storke”. The pile driving tower was attached to a mobile Fushun crawler crane, Model QUY 80, with 19 metres of boom rigged on the crane. Figure 1 shows a diagram of the crane and piling rig configuration.

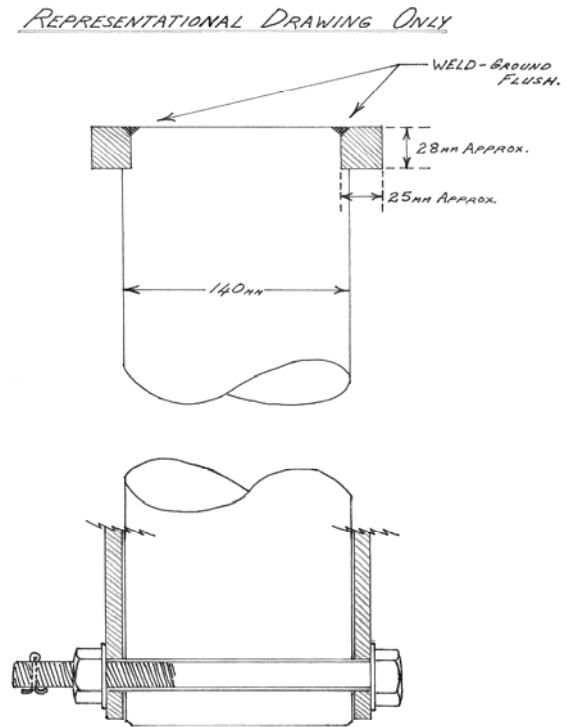
Figure 2 – Section view of pin showing welded ring as flange
